KA Sail Australia a division of Kingston Range Pty Ltd

WASZP upgrades

Andrew McDougall, December 2017

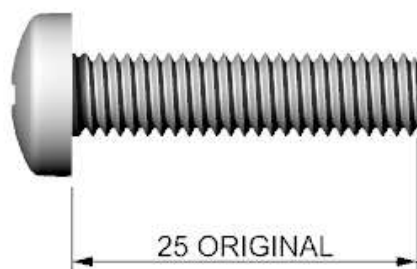
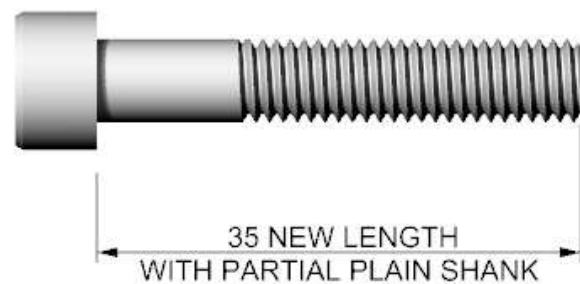
Gantry Bolts

If your Gantry bolts only measure 25 mm (excluding the head) there is a possibility they are not reaching the stainless-steel tapping plate inside the boat and are only being screwed into composite. If this is the case, eventually they will pull out causing gantry failure and possibly damage to your boat. Not to mention difficulty getting the boat back to the beach. We are providing 35mm bolts which may be too long to go into the hole. In this case we strongly recommend you clean out any glue in the hole and if necessarily drill the backing out (with a 5mm drill) so that the screw can go to full depth. If you pierce the backing cover, this is not a problem as it is best to put something like silicon or Sikaflex (291 is what we use) inside the hole when you screw the gantry in.

Pack to choose: **1 (Gantry Fixings kit)**

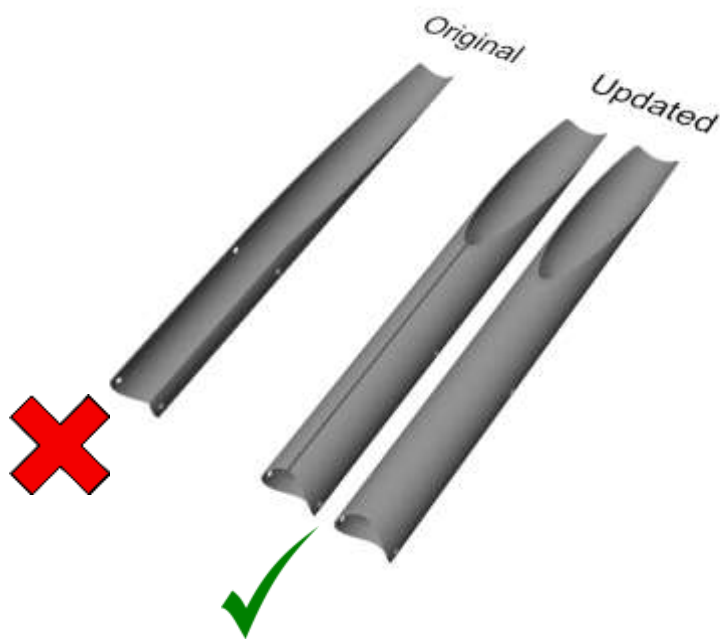
Wing Tube Sleeves

The original sleeves strengthening the front and rear wing bars only wrapped 70% the way around the wing bar. We found that under high hiking loads the sleeve could crack allowing the wing bar to bend or even fail. We have developed new wing sleeves which fully wrap or have a small slot. If you have the original with the 70% coverage please choose the upgrade. Please also check if any of your main wing tubes are bent. If so select the tubes you need from the main webstore and select 'Submit to KA' on checkout so that we can adjust the price to zero.

Pack to choose: **3 (Sleeve kit)**

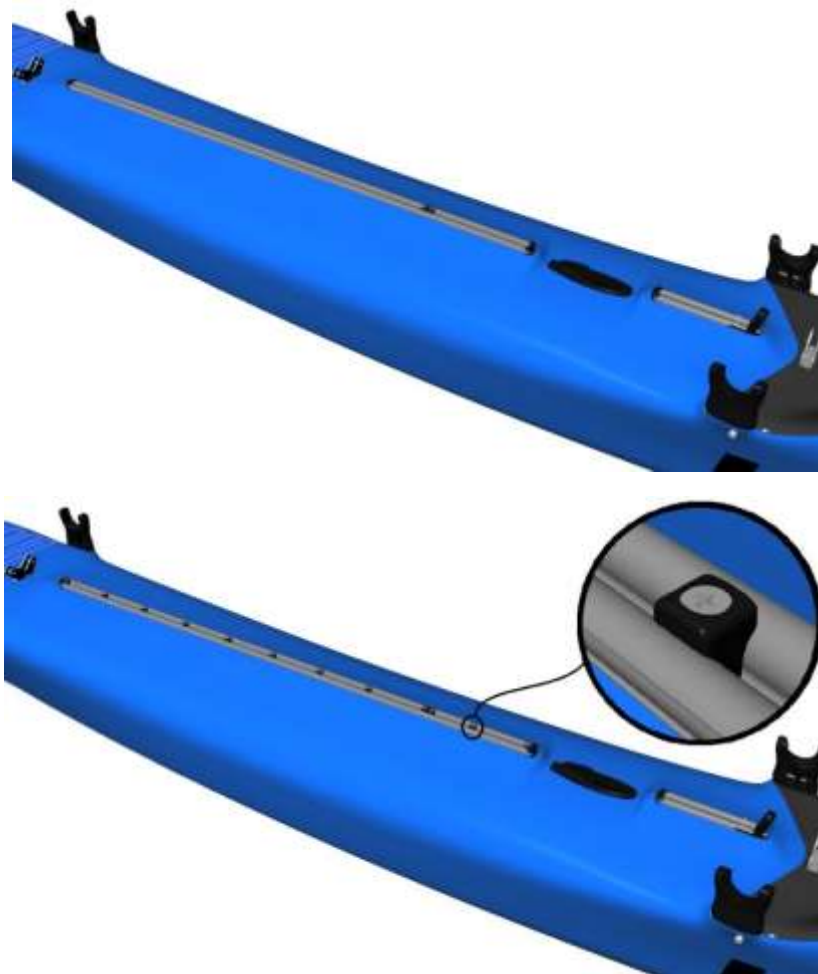
Bolt Rope Track

In early boats (pre ~2160) this bolt rope track was not bedded down on a raft of Plexus glue. This allowed the track to move and possibly break the M3 bolts holding it down.

The solution is to upgrade bolts to 4mm with a plastic insert to spread the load on the bolt.

- If your boat # is higher than 2160, it is only a precaution. No action is OK.
- Install the new bolts and inserts yourself and receive a \$50 credit on our web store (or with local agent) – see video [Bolt Track Upgrade](#). Tools are provided in the kit but you will need a cordless drill with Phillips #1 and #2 screw driver bits.
- If you are not comfortable with doing it and your boat # is below 2160, please get a quote to get it done for you and submit a warranty claim:

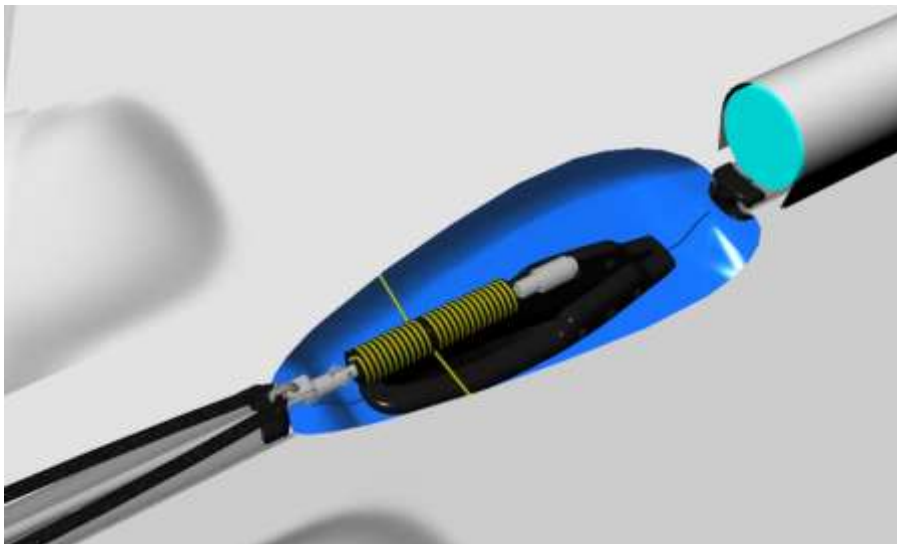
Ride Height Adjuster Barrel V1

The first item that started to fail was the original ride height adjuster. Initially we re-engineered the part with a single internal bush rather than the split one which could have the right height adjuster to breaking in half. In tandem with this we decided to completely redesign the right height adjuster to make it much easier to use forming a more inverted barrel shape. So: - if you have the ride height adjuster as shown in this photo we can send you the new style. Some people actually prefer the old style as it gives you a better visual feedback of where your right height is. Personally, I like the new one as it is less likely to tangle than the old one. See video [RHA_V2](#)

Pack # to choose: **2 (Ride Height control upgrade)**

If it has not broken you may want to keep with it, even so we can still send you the upgraded version

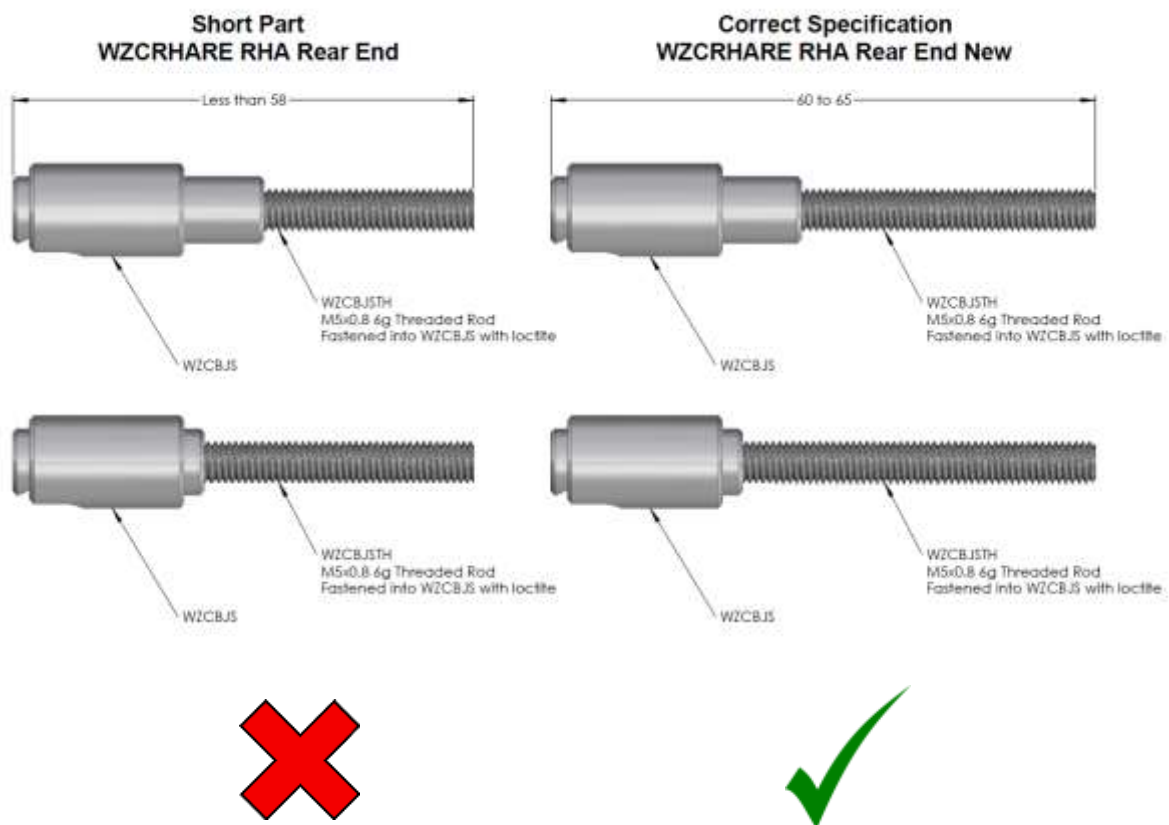
Ride Height Adjuster Update

The new ride height adjuster created another problem: some were provided with the ball joint socket (shown here) being too short and there was not enough range in the right height adjuster (sometimes resulting in losing the right height adjuster barrel). If the total length of the supplied RHRE part is less than (<) **60 mm**, please select the new RHA Connector pack to extend this part to the correct length.

Note there are two types of socket heads, both are OK.

Pack # to choose: **4 (Ride Height Adjuster connector update)**

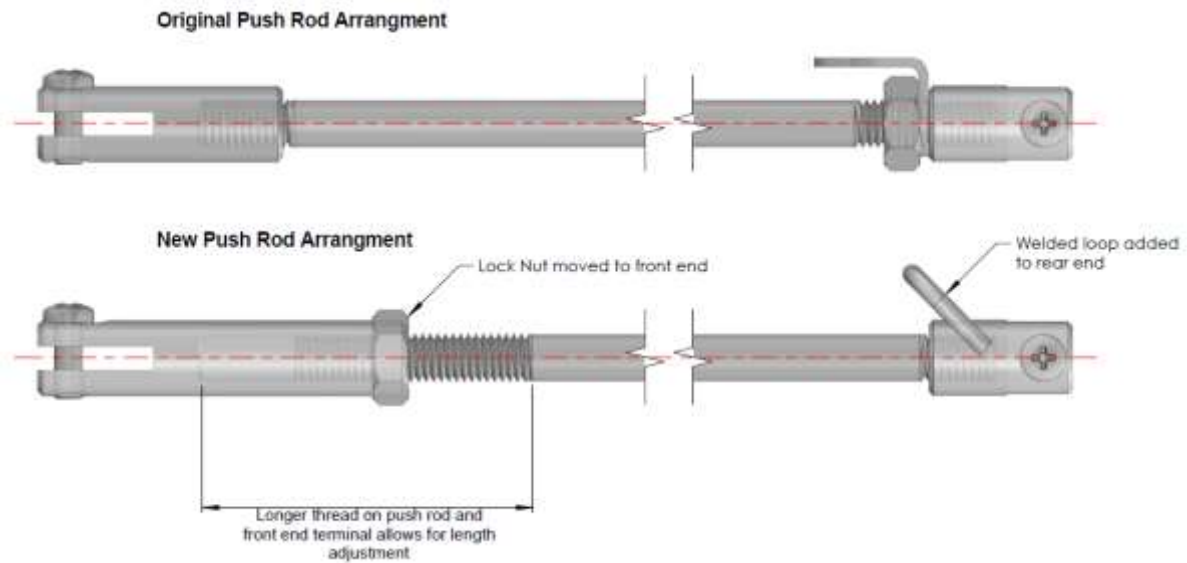
Adjustable Push Rod

We found that there were variations in the boat and parts, enough to cause the wand to not to be able to actuate the flat in the correct range, making the boat difficult to control. To get around this issue we have a new push rod and ends, which allows for full adjustment to get the setup right. See Video [Push Rod Upgrade](#)

Pack # to choose: **5 (Push Rod Upgrade)**

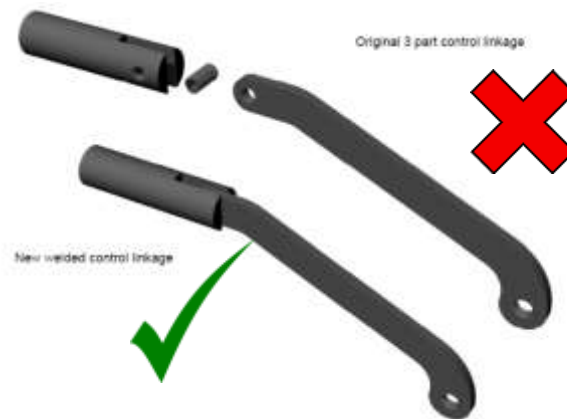
Wand Control Link

There have been issues with a grub screw joining the wand link to the slider just behind the wand. This could come out and cause the wand to be restricted and causing control problems. It also can dislodge the slider casing from the boat. The new slider has a welded pin that cannot cause any problems.

See video [Pullrod System Upgrade](#) for instructions on how to replace.

Please check that your slider casing is still securely glued in place: Add it to your order if not.

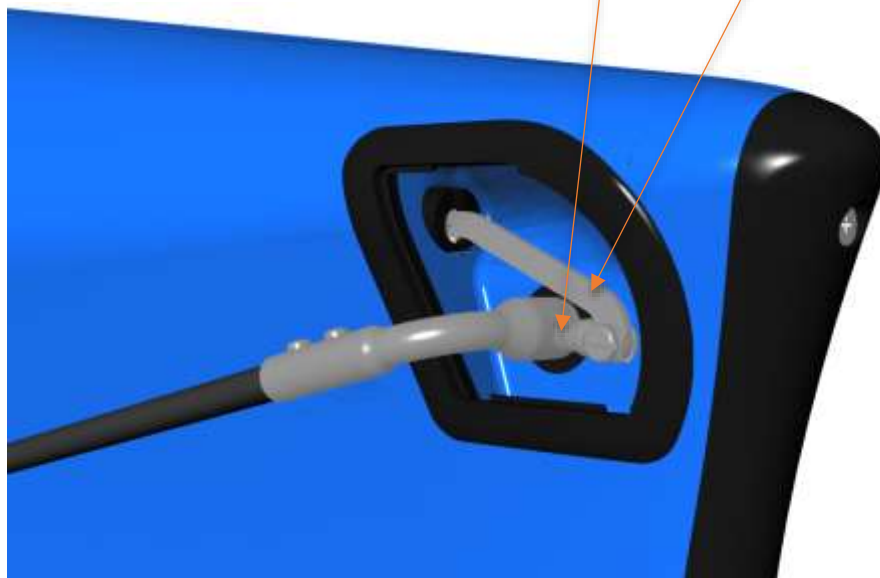
Gearing Setting

Some of the problems have been due to the factory gearing setting wound out too far, stressing the system. Please reset this to a maximum of 4 turns out (This was listed as 8 turns in earlier instructions). As you get more skilled wind the adjustor in to almost 0 turns, unless you're sailing in extreme wave conditions.

I also want to talk about how to attach the gearing adjuster to the wand link. As the two halves of the fork on the adjustor and the wand link all are threaded, it is important to pull the wand link outwards until the link is against the inside of the fork on the adjustor. This is so that the fixing screw picks up the thread in the wand link plate immediately the screw emerges from the outer half of the fork, before pushing it to the other side.

If the link is jammed on one side it can cause the wand not being able to extend forwards. Note that both parts have a thread which has allowed us to make the components small and tough but do require a little bit of thought when assembling. See video [Pullrod System Upgrade](#).

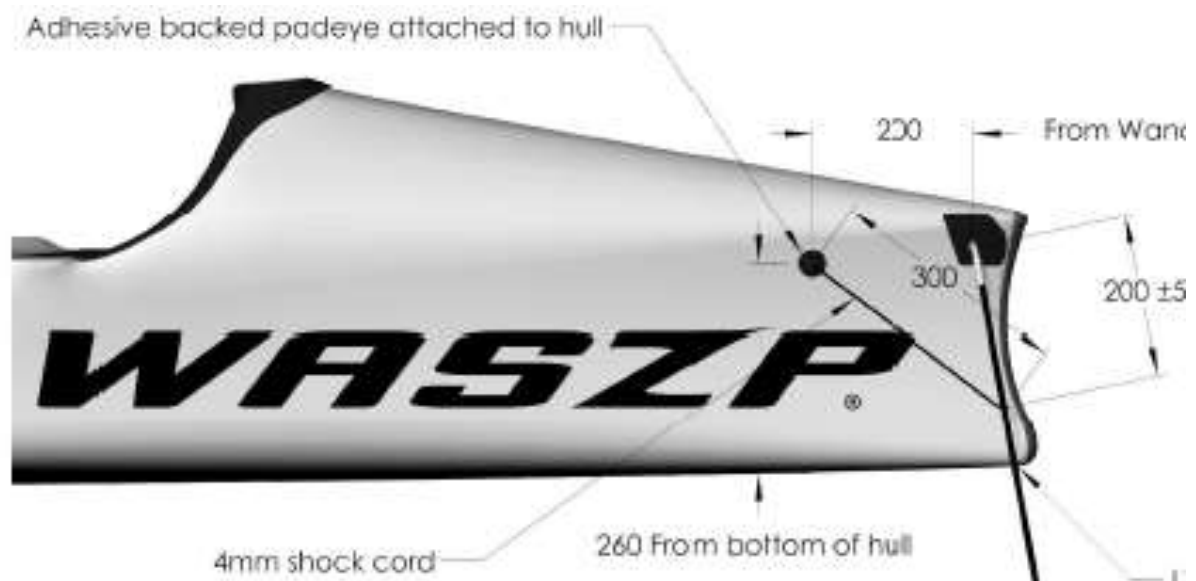
Wand Limiter

With all the tweaks we are doing, the wand should flick forward easily, which is great for waves and strong winds, but not so great at other times. We have included the tether and bungy. The limiter allows you to adjust the flick by sliding the bungy along the wand shaft.

See video [Push Rod Upgrade](#) and for placement see below:

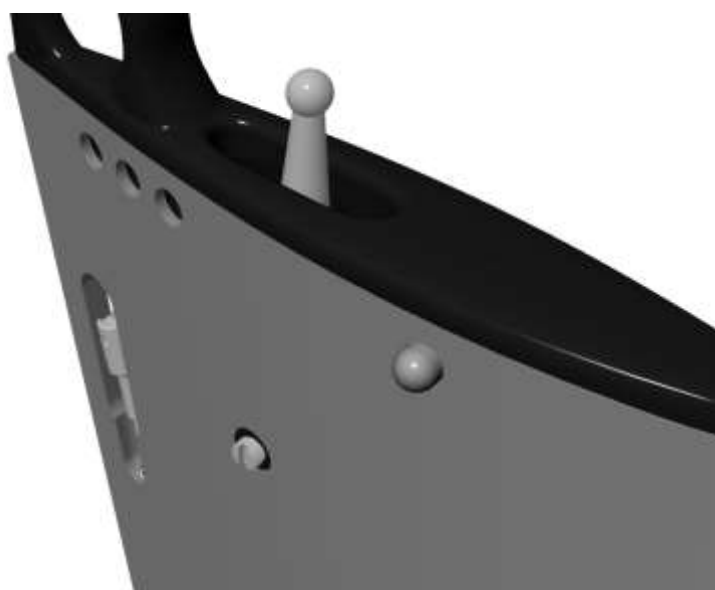
It is possible that the Bell Crank Axle could work out causing poor operation of the flap and also difficulty getting the foil out of the case. We have now changed the Loctite specification that is used to 680 - a high strength Loctite specifically designed for plastics. A reasonable solution is to use superglue if you discover the Bell Crank Axle is loose. If you find that the thread has been stripped in the plastic that the Bell Crank Axle sits in, please select this in the webshop with your upgrade pack.

Bell crank axle working out of the front vertical foil

See video [Bell Crank Axle Fix](#) for instructions.

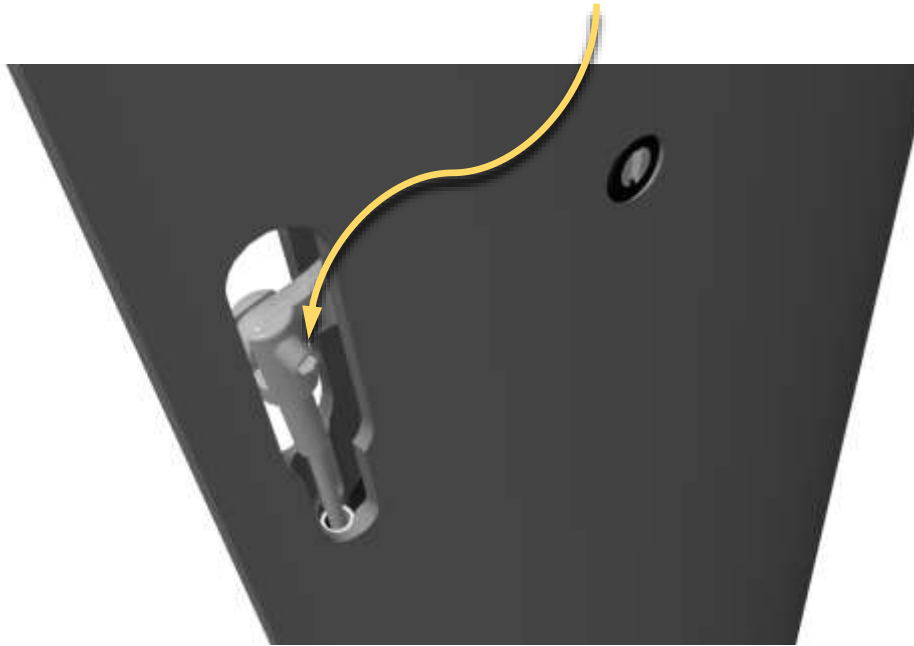
Lost / Damaged grub screw in foil push rod top terminator

When assembling the front foil, it is easy to lose or damage the grub screw. We are updating our instructions to show a way to assemble without removing this. See video [Front Foil Disassembly](#). If you do remove the grub screw, don't use force to put it back in as both parts have threads it needs care to line up.

Pack # to choose: Grub Screw is included in pack **#1**. (But may need WZFFPRTT Top terminator)

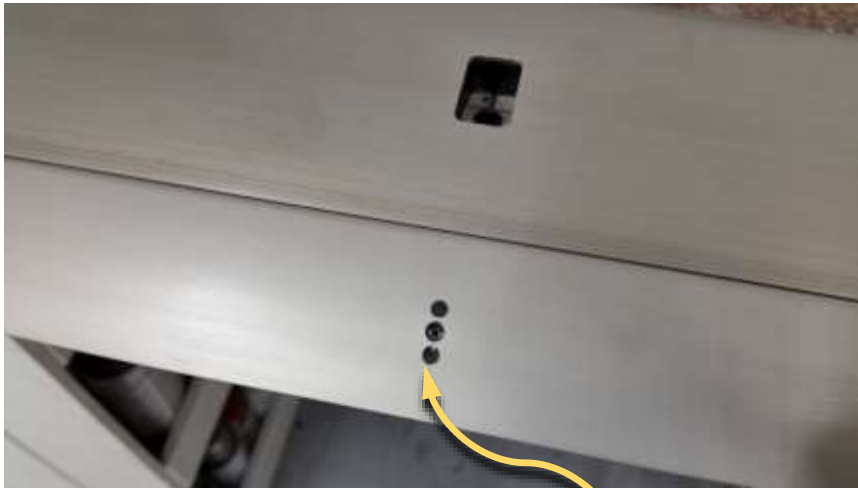
The barrel nut is a small metal part inside the front foil flap that connects the pushrod to the flap. The design is the same as what had been used successfully in the Mach2 for many years. We discovered that the openness of the aluminium section used in the WASZP allowed the barrel nut to bend and sometimes break, resulting in the pushrod pushing through the bottom of the flap. There have been two stages of addressing this problem: The first was to inject the area with glue to encapsulate the barrel nut, the second stage, coming online now, has been to create a new extrusion die for the flap that encapsulates the barrel nut completely. This new section has been coupled with rethinking the tip attachment so they can be removed and replaced more easily. It also allows replacement of the barrel nut. If your foil does not have two injection holes near the barrel nut or screw holes near the tips that signify the tips are removable, then the barrel nut has a possibility of failing.

1. Leave it. If it fails we will repair or replace. We extend the warranty on this part to 3 years.
or
2. Receive an AU\$50 credit on the web store if you inject the foil yourself. (Upload a pic of the injected glue, before trimming, in a warranty claim). Video: [Barrel Nut Injection](#)
or
3. Buy the new specification foil for 40% off for a limited time.
or
4. Not practical for the majority of locations – to get the foil back to our main offices for injection (Melbourne Australia or Lugano Switzerland. More options may come available).

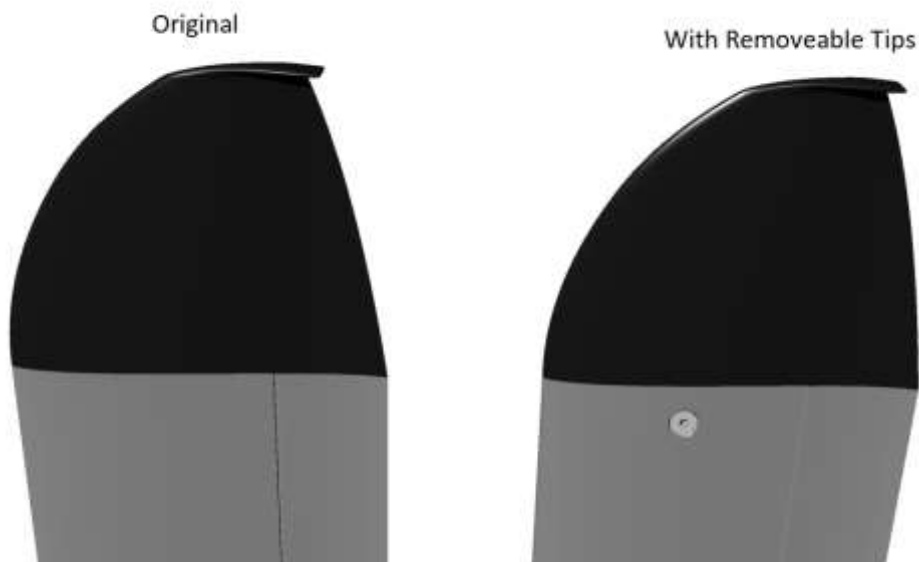
Image showing additional holes to inject spabond.
